Manhole Inspection Summary

Manhole # S19OO1014MH

Location Address: **2020 BRAND AVE**

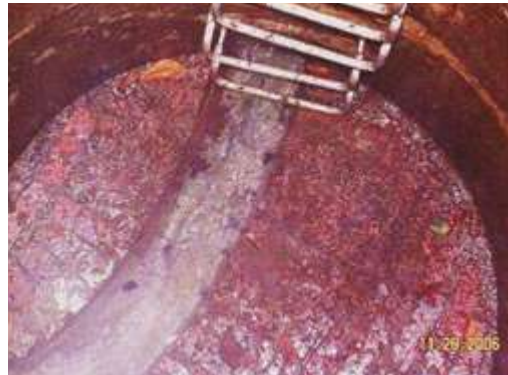
Top View

Bench ☒ Exists Material: **Brick** ☐ Parged ☒ **Debris** (not Condition related)

Bench debris.

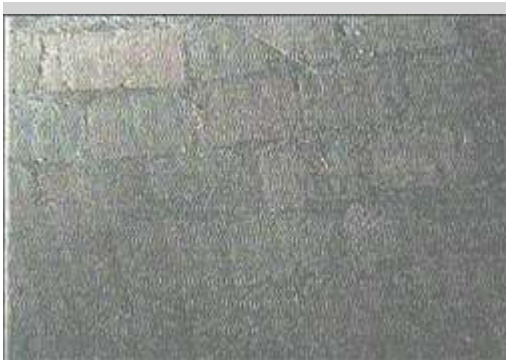
Defect

Condition: ☐ Sound ☐ Cracked ☒ **Root Intrusion** ☐ Loose Brick ☐ Deteriorated

Infiltration: ☐ None ☐ Joint ☐ Cracks ☒ **Mortar** ☒ **Roots** ☒ **Wall**

Corbel root intrusion and infiltration.

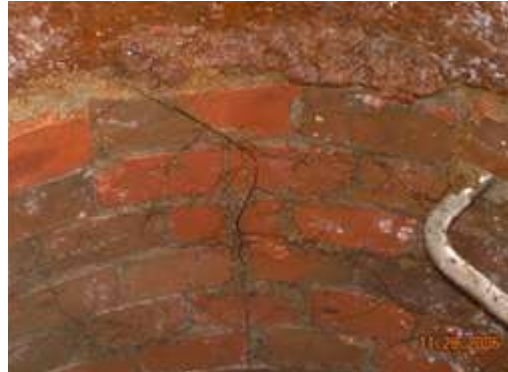
Defect

Condition: ☐ Sound ☐ Cracked ☒ **Root Intrusion** ☐ Loose Brick ☐ Deteriorated

Infiltration: ☐ None ☒ **Joint** ☐ Cracks ☐ Mortar ☒ **Roots** ☒ **Wall**

Adjustment root intrusion and infiltration.

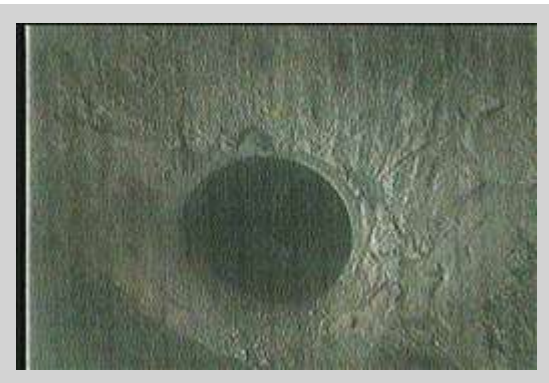
10 in. Circular Gravity Sewer Pipe In @ 7 O'Clock

Infiltration: **Evidence** Pipe Seal Cond: **Unknown**
